# Manhole Inspection Summary

Manhole # S47II\_044MH

Insp Date: **5/1/08 8:27 AM**

**Location** Address: **Montford Ave**

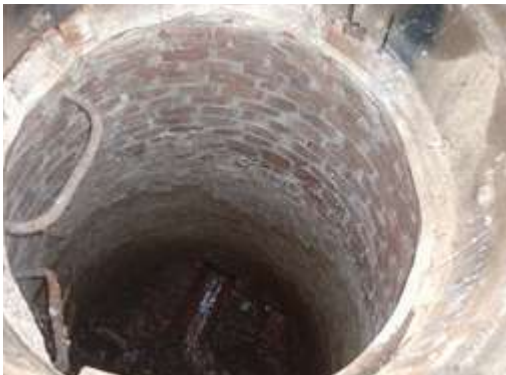
Defect 2

Infiltration

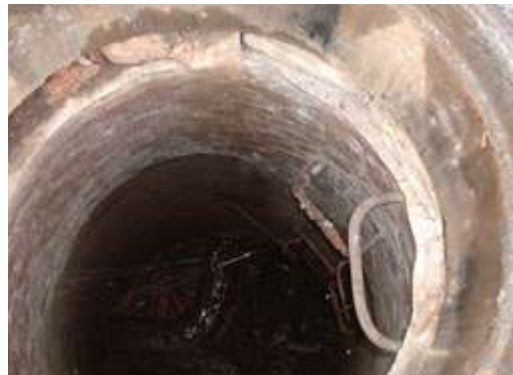
Defect 1

Condition: ☐ Sound ☐ Cracked ☐ Root Intrusion ☒ **Loose Brick** ☒ **Deteriorated**

Infiltration: ☐ None ☐ Joint ☐ Cracks ☒ **Mortar** ☐ Roots ☐ Wall

Deterioration

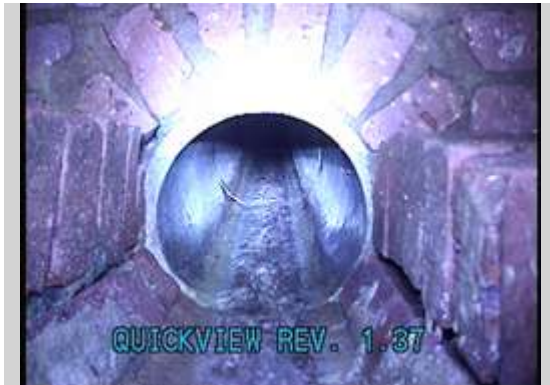
12 O'Clock Outflow

8 in. Circular Gravity Sewer  
Pipe Out @ 12 O'Clock

Pipe Height: **8.4** (in.) Rod and Bar (Angled)  
Pipe Material: **Clay** ☐ Pipe Lined  
Invert Depth: **10.35** (ft.) Flow Characteristics: **Fast**  
Deposits: ☒ None ☐ Mud ☐ Sludge ☐ Debris ☐ Grease  
Silt Depth: (in.) Deposits Extent:  
Infiltration: **None** Pipe Seal Cond: **Sound**

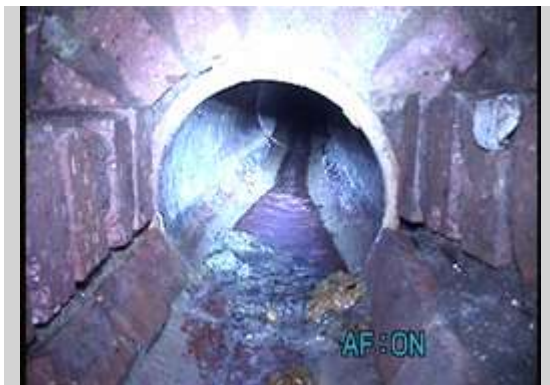
3 O'Clock Inflow

8 in. Circular Gravity Sewer  
Pipe In @ 3 O'Clock

Pipe Height: **8.4** (in.) Rod and Bar (Angled)  
Pipe Material: **Clay** ☐ Pipe Lined  
Invert Depth: **10.15** (ft.) Flow Characteristics: **Fast**  
Deposits: ☒ None ☐ Mud ☐ Sludge ☐ Debris ☐ Grease  
Silt Depth: (in.) Deposits Extent:  
Infiltration: **None** Pipe Seal Cond: **Sound**

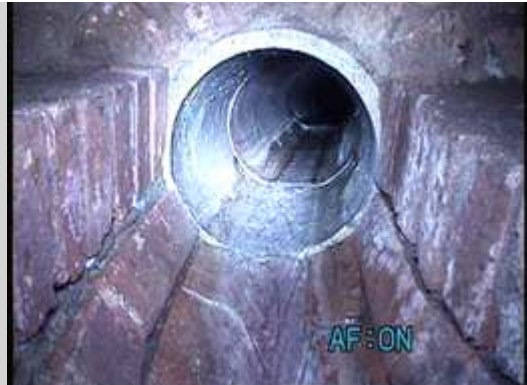
9 O'Clock Inflow

8 in. Circular Gravity Sewer

Pipe In @ 9 O'Clock

Pipe Height: **8.4** (in.) Rod and Bar (Angled)

Infiltration: **None** Pipe Seal Cond: **Sound**
